THAMES FLOODING JANUARY 2024 - SECTION 19 REPORT

EXECUTIVE SUMMARY

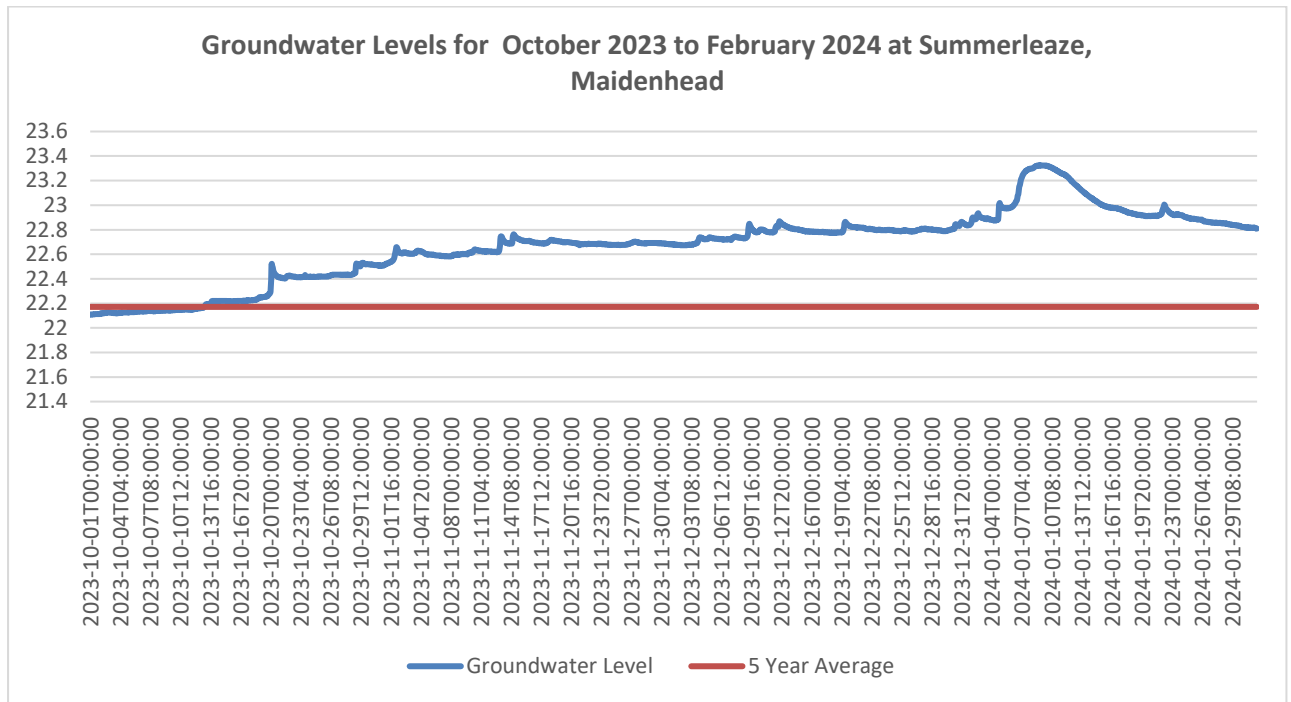
Figure 8-Groundwater readings in meters above ordnance datum from October 2023 to February 2024 taken at Summerlease, Maidenhead, alongside the 5-year average.

The figures show that up to January 2024, groundwater levels were above the 5-year average level and continuing to rise. The data from the Summerleaze gauge shows a spike in groundwater levels immediately after the rainfall came from Storm Henk. This is likely to account to any capacity in soil moisture being taken up and the water flowing through the river gravels as river levels began to rise. There is no data for this time from the Albany Park gauge however it is likely to be similar.

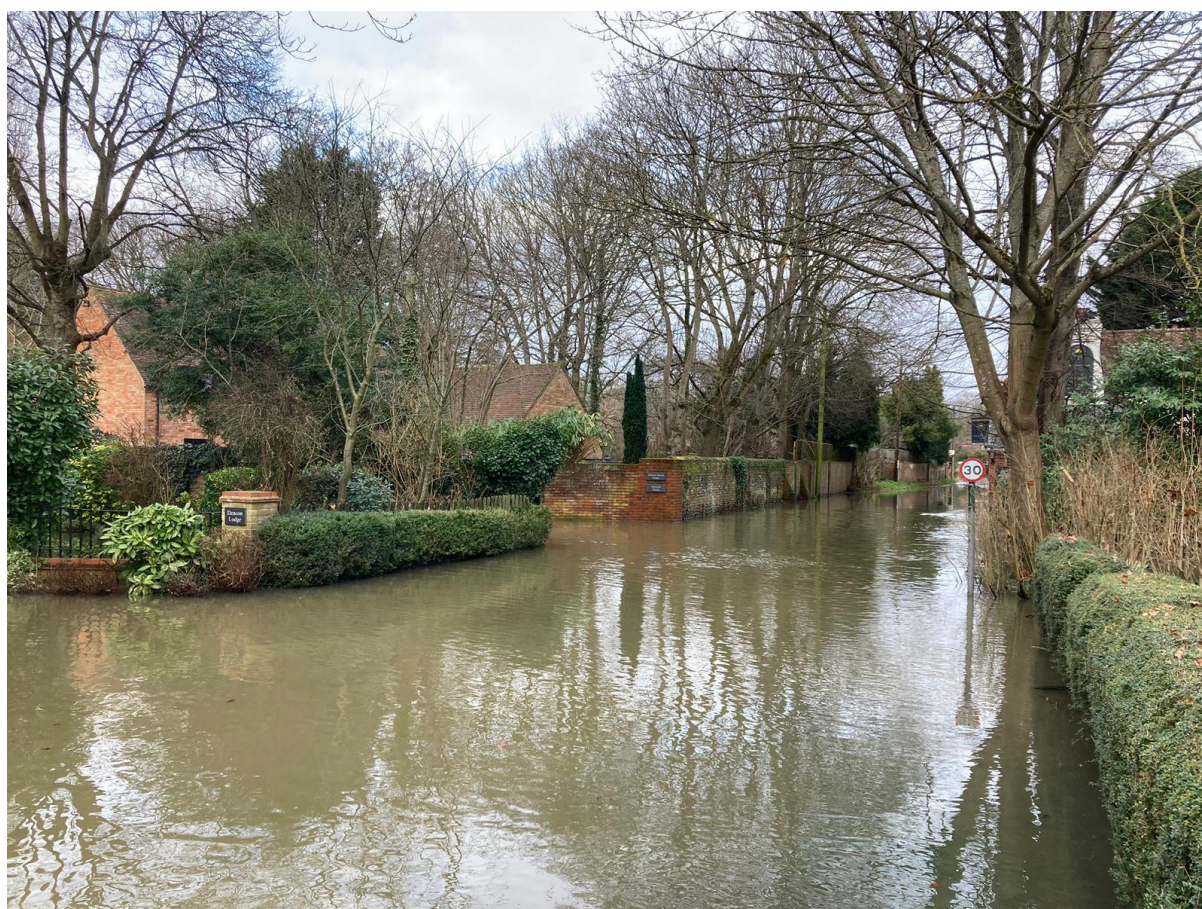
The flood waters that met the Bisham Brook caused the watercourse to flow at bank full level however the watercourse prevented further flows to the south. Instead, water flowed to the east following the route of the watercourse. This flow continued until the Bisham Brook meets Hurley High Street. The culvert that takes water under the road acted as an obstruction causing water to break from the banks of the brook and flood one property internally and one externally. The water that flowed out of the brook flowed over the High Street but flow but could not re-enter the brook due to a wall built up on the east side of the road.

Figure 16- Photo showing flooding to Hurley High Street

This caused flooding to the High Street, which in combination with the flooding at the junction of Shepherds Lane meant that that approximately 400m of the road was impacted, from the junction of Mill Lane to the junction with Bell Court. Residents reported bow waves were being created by cars as they drove through and that this even continued following the road being closed, with residents reporting that this was the difference in some cases between a property flooding internally or not.

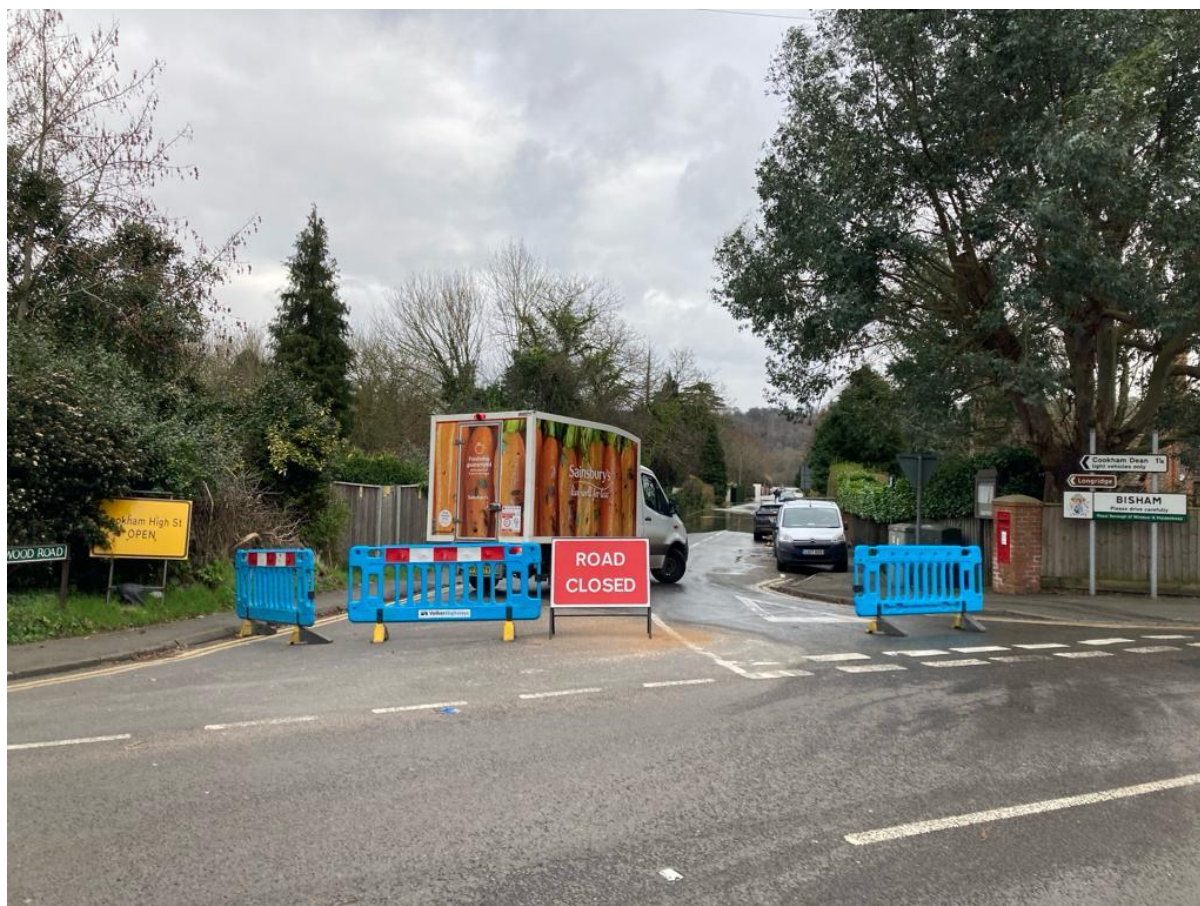
Figure 18- Road closure of Quarry Wood Road, Bisham

The flow routes of fluvial water mentioned in the Description of Flooding were likely the result of lower walls and banks on that part of the Thames. This was also the cause of the closure of Quarry Wood Road as the flow routes were observed between the junction with Bisham Road and west of the A404 bridge.

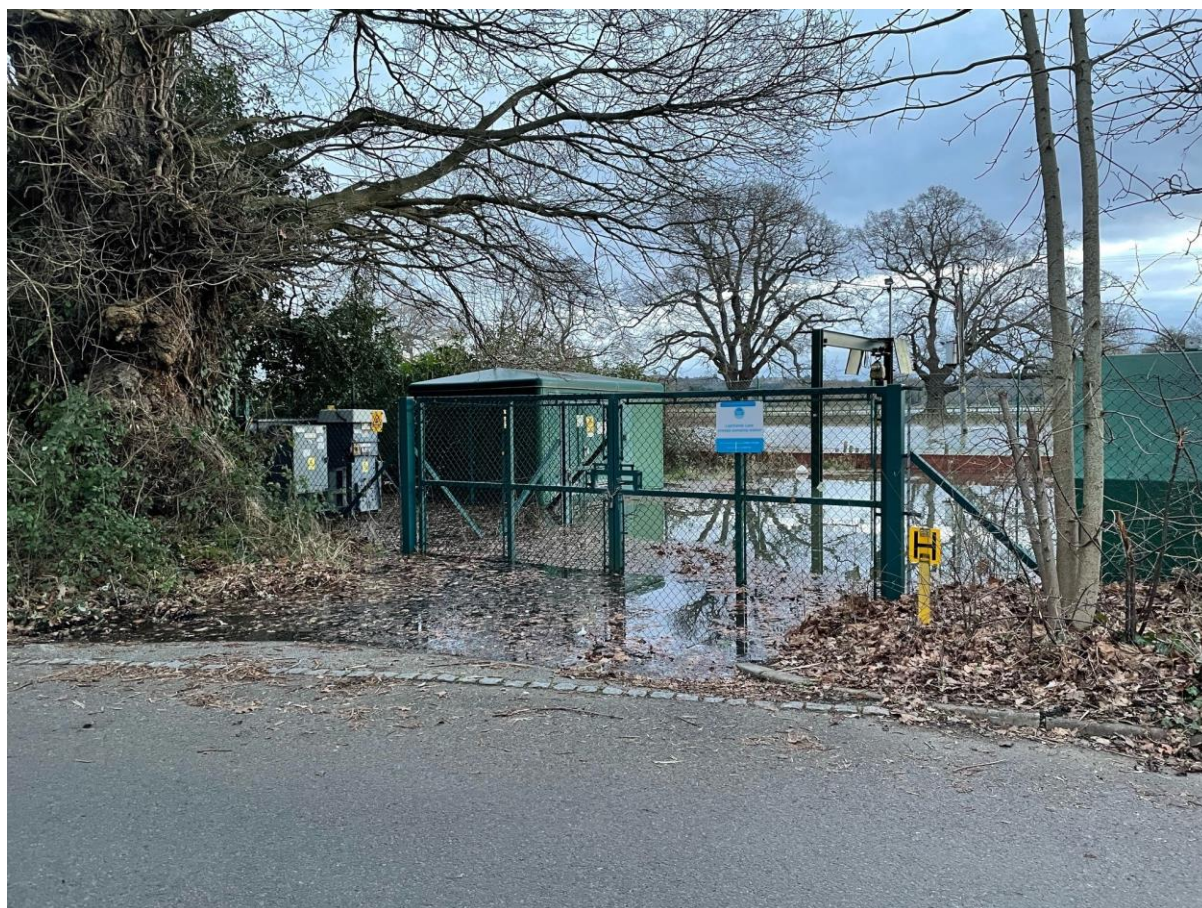
There was also loss of the sewage network in areas such as Lightlands Lane and Westwood Green due to the loss of power to the sewage pumping station on Lightlands Lane.

Figure 20-Photo showing flooding to the Lightlands Lane Pumping Station

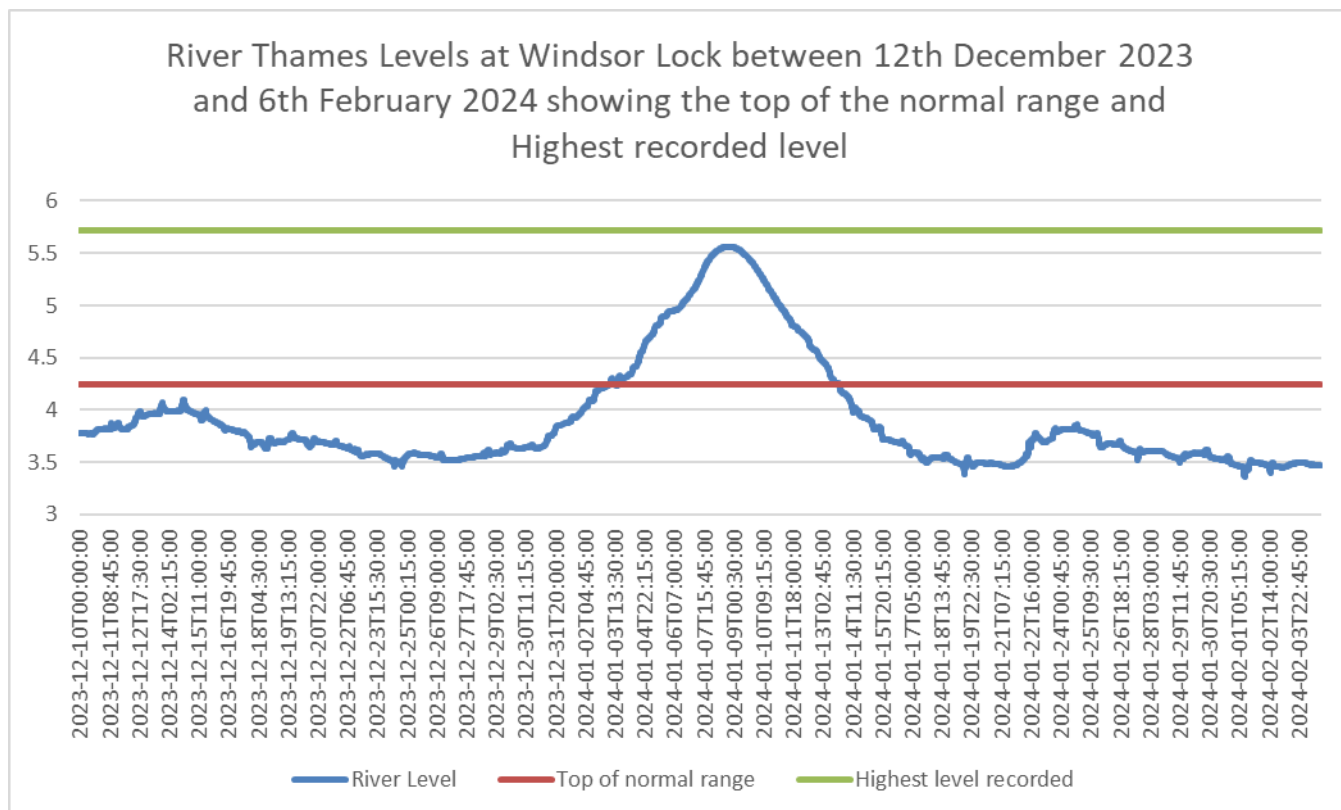
The peak of the flow came through Windsor Lock, upstream of Datchet, on 8th January 2024 as shown in Figure 20.

Figure 21- Graph showing River Thames levels in meters at Windsor Lock from 12th December 2023 to 6th February 2024.

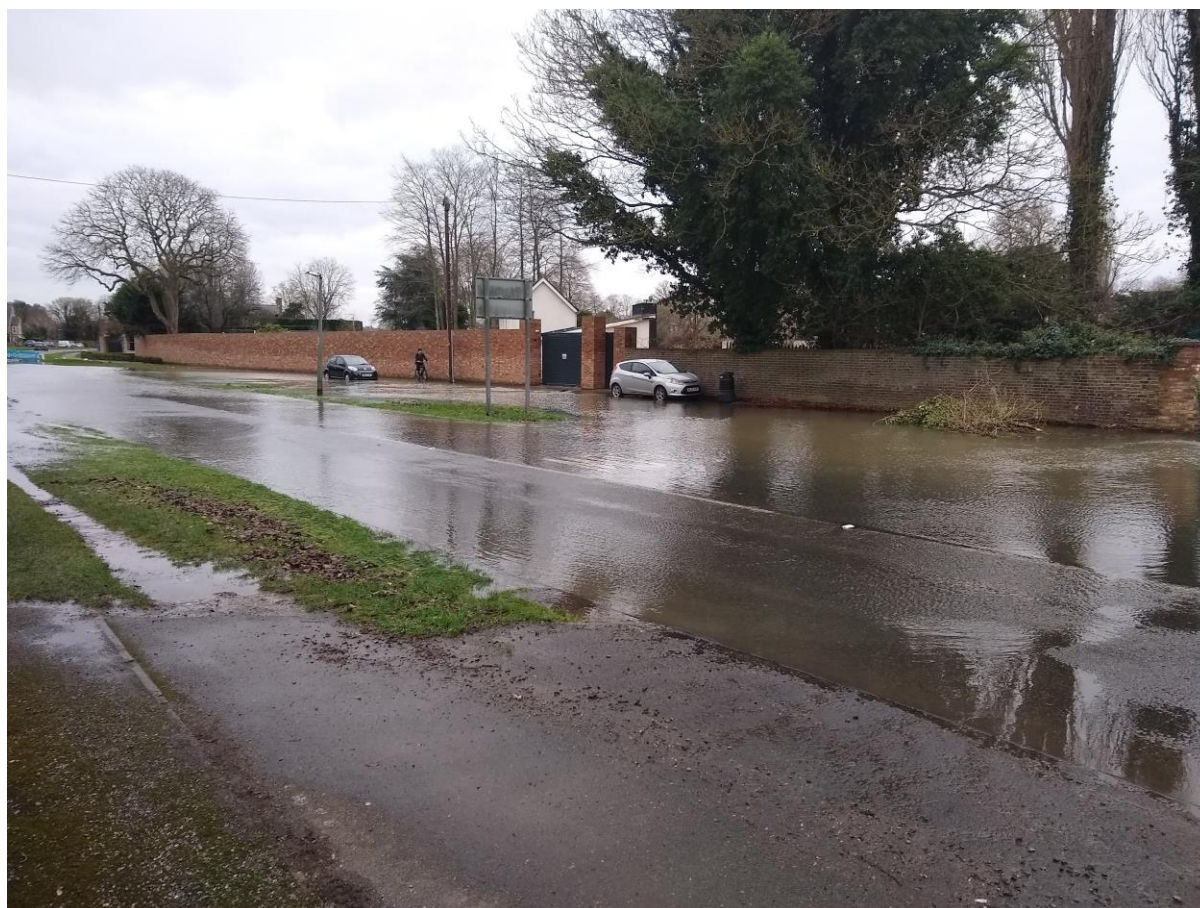
Figure 22-Photo showing flooding on Southlea Road, Datchet

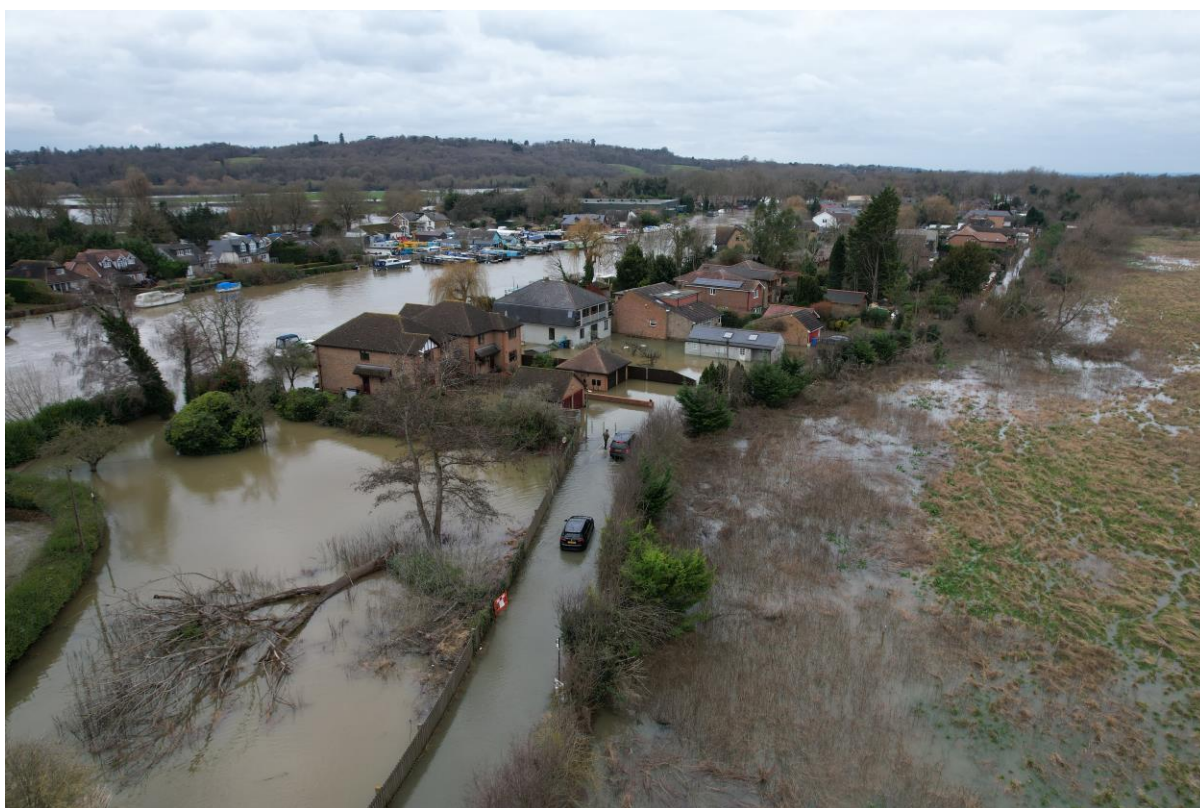
Figure 24-Photo showing flooding around Hythe End Road, Wraysbury

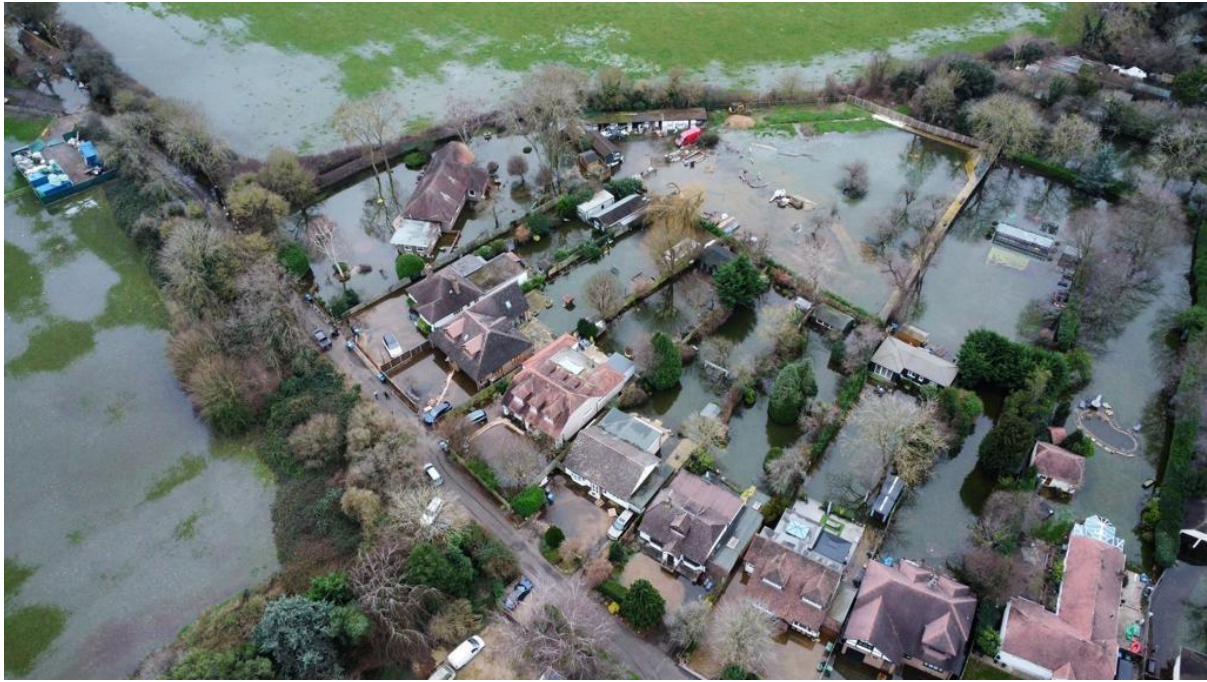
This flow from The Avenue also continued into the adjacent lakes increasing the water levels. It is believed this was a major driver as to why groundwater was high in Wraysbury for so long after the incident. This high ground water meant that flood water around properties away from the river took a long time, in some cases months, to soak away. As such, Wraysbury was not able to fully recover from the incident for some time. This was not helped by the local drainage infrastructure, such as the Wraysbury Drain, being impeded at downstream sections such as in Hythe End and in the Ankerwyke site. This further reduced the ability for Wraysbury to drain away its flood water, increasing the amount of time water remained following the flooding. The Parish Council have also raised concerns that this is a wider issue for many watercourses in Wraysbury and may have prevented other areas of pooling water to flow away.

Figure 25-Photo showing flooding to properties around Garson Lane, Wraybury

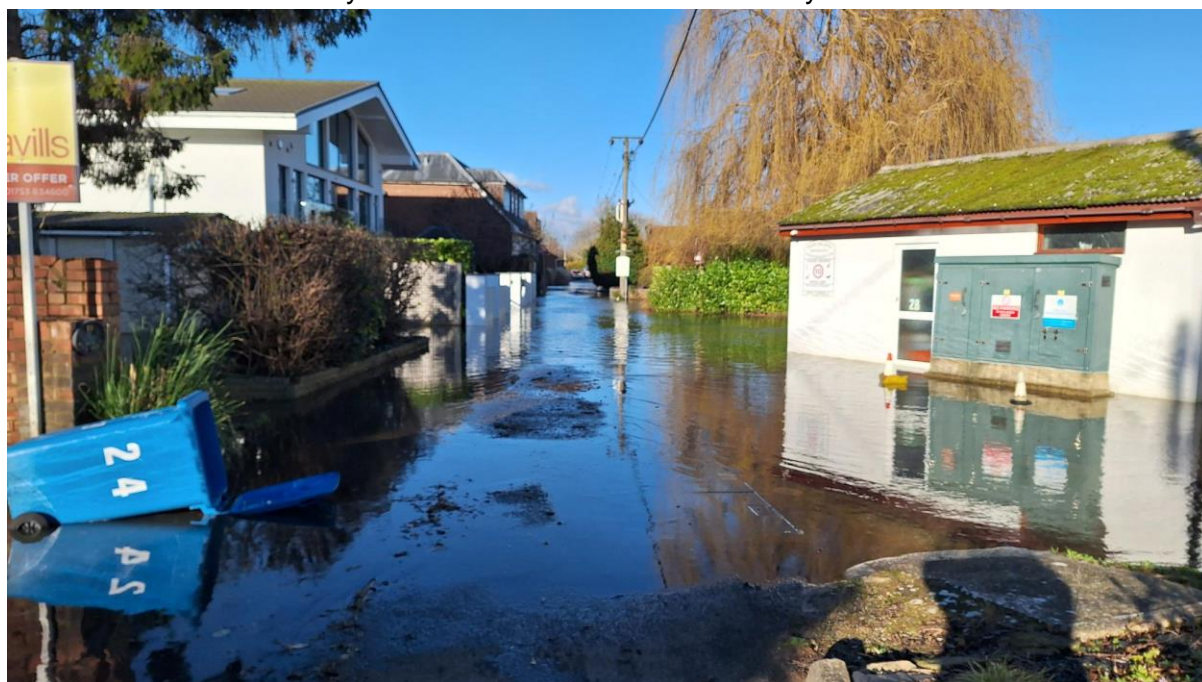
The majority of the reported flooding that occurred in Old Windsor was recorded on Ham Island. The flooding to Ham Island came from two main directions. The first of these to occur was when the wall that makes up the western boundary between the properties and the river was overtopped. This started at one property but spread to the others that make up this boundary between numbers 23 and 25. This resulted in some of those properties nearest the wall to be flooded internally and others to be flooded externally.

Figure 26- Photo showing flooding at Ham Island

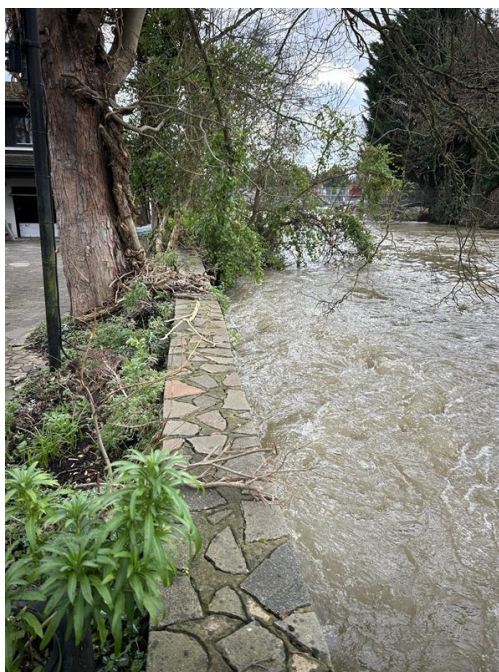
The first of these local features was the wall at Ham Island. While it did not cause flooding, residents were concerned throughout the peak flow of the Thames that the condition of the wall may cause it to collapse which would create a surge of water towards properties. The reason for this concern is that the wall has a number of cracks which residents observed flood water coming through. Water levels were high against the wall for a prolonged period of time also which residents were concerned would put additional strain on the wall. The level of the Thames during the peak of flow was higher than the level of the wall. This resulted in water flowing over the wall like a weir and flowing quickly towards the properties closest to the wall.

Figure 27- Photo showing the River Thames flowing next to the wall at Ham Island on 6th January 2024
